REPORT NO. GDCA-DBG73-002
CONTRACT NAS9-12326

DETECTION OF FATIGUE CRACKS BY NONDESTRUCTIVE TESTING METHODS

GENERAL DYNAMICS
Convair Aerospace Division

March 1973

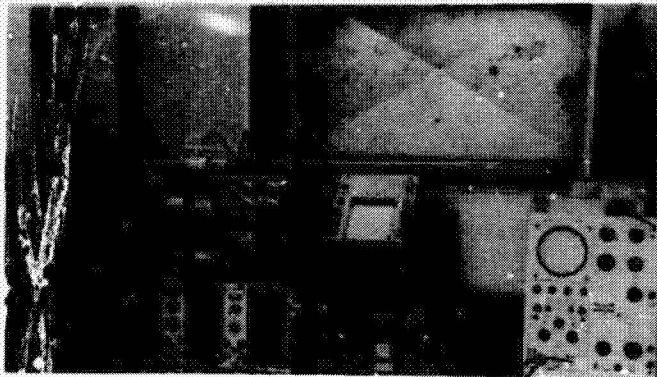
Figure 2.3-1. Acoustic Emission Monitoring Setup for Detecting Fatigue Crack Growth

The general test setup is shown in Figure 2.3-1 with a specimen mounted in a tensile fatigue test machine. Figure 2.3-2 shows the construction of the transducer. The active element is lead-zirconate-titanate Glennite HDT-31 plate 0.51 mm (0.02 in.) thick by 5.1 mm (0.2 in.) square. A whisker wire is spot soldered to the back for connection to the coaxial lead wire. A compression spring (not visible) is used to provide steady intimate contact of the crystal face and the test specimen. A soft rubber pad insulates the spring from the crystal and whisker wire. A silicone base grease is used as a couplant on the crystal face. The brass case is clamped to the specimen holding the

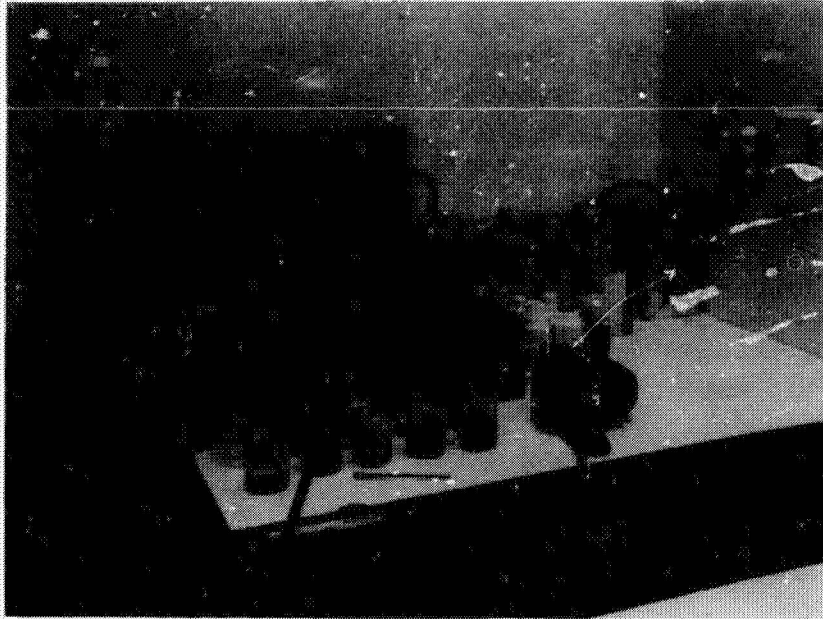
Figure 3.2-2. Fluorescent Penetrants and Hydrowash Apparatus

An air-assist hydrowash comprised of a sprayer head and air input manifold with pressure regulation was used. The system applied penetrant removers and enabled forced-air water wash in instances where the high dimensional threshold stability of super-sensitive penetrants would otherwise increase the presence of background fluorescence thereby inhibiting defect detection and/or accurate measurement of defect size.

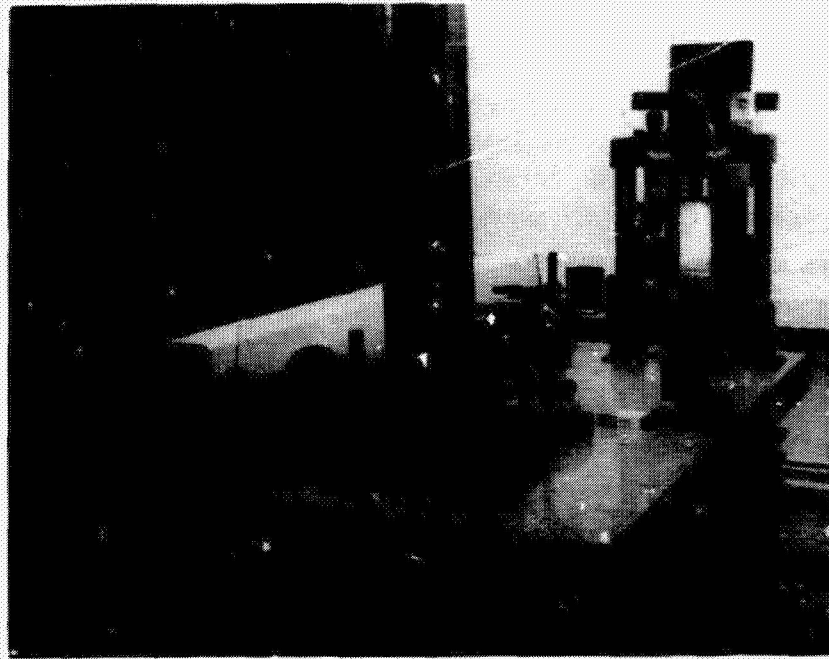
Figure 3.7-1. Holographic Interferometry Apparatus

The basic holographic experimental apparatus is shown in Figure 3.7-1. The beam of laser light is divided by a beam splitter into a reference beam and an object beam. Each of the beams is expanded on passing through a pinhole assembly: a $10\times$ microscope objective and a $25\text{-}\mu\text{m}$ pinhole spatial filter for the reference beam, and a $20\times$ microscope objective and a $25\text{-}\mu\text{m}$ pinhole spatial filter for the object beam. Components were selected and the pinhole assembly for the reference beam was positioned so that when the optically-filtered beam expanded after reflection from the reference mirror it fully and efficiently illuminated the $10.2\times 12.7\text{ cm}$ ($4\times 5\text{ in.}$) holographic plate with a spherical reference wave. In a similar manner, the components were selected and the pinhole assembly for the object beam was positioned so that the expanding spatially-filtered beam just fully illuminated the useful long dimension – central 20.3 cm (8 in.) – of the specimens. This efficient arrangement of reference and object beams shortened the exposure times required for recording the holograms, thus minimizing any stability problems during exposures in the holographic setup. The setup, which was located adjacent to a factory machine shop and overhead aircraft environment, is described below.

A 50-mW He-Ne laser was used as the light source. All double-exposure holograms were recorded on Agfa-Gevaert 10E75 high-resolution holographic plates, which were subsequently developed in Kodak HRP developer.

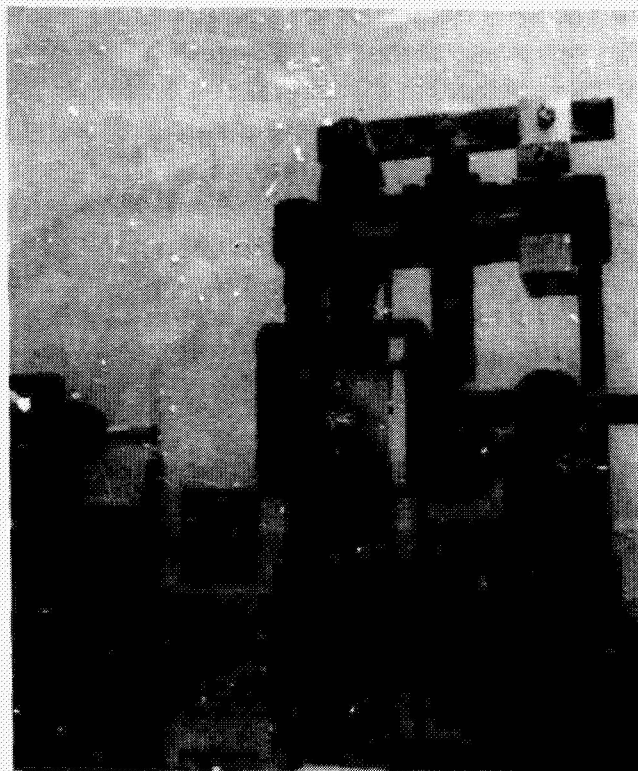
Figure 3.7-3. Tensile Loading Device (C_2 Configuration)

Use of configurations C_1 and C_1' for the B (nominally 5.72 mm (0.225 in.) thick) specimens, and C_2 for the A (nominally 1.52 mm (0.060 in.) thick) specimens resulted in best control of the pressure leak in the hydraulic piston unit.

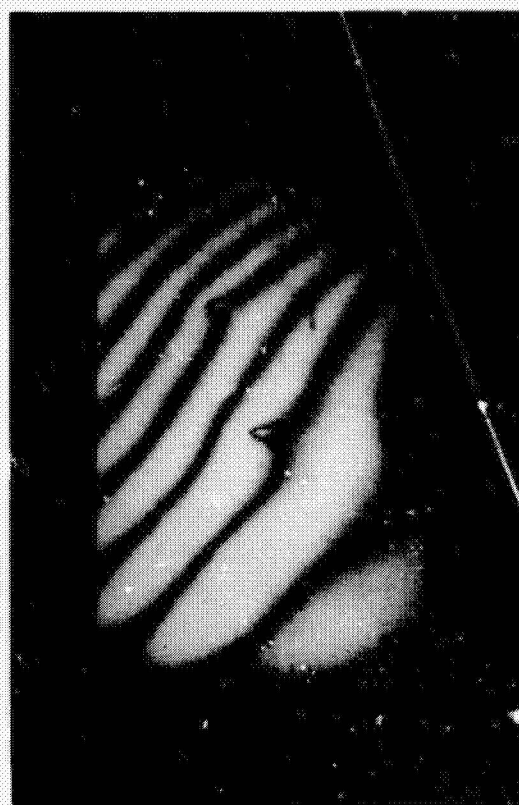
Figure 3.7-5. Polaroid Print of Reconstruction of Double-Exposure Hologram A-24 P34
